LIITE 1

RAKKOLEVÄN LEVINNEISYYSMUUTOKSET

METHODS FOR ASSESSING THE STATE OF FISH REPRODUCTION AREAS IN THE ARCHIPELAGO SEA, SW FINLAND

Ship-induced erosion on the shores close to a main navigation route in the Archipelago Sea, SW Finland - a case study

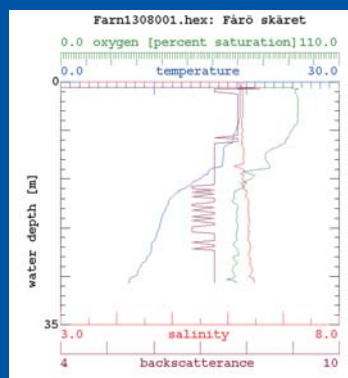
CTD-data from Färö skäret in the southern Archipelago Sea. Temperature, oxygen saturation, salinity, and turbidity (back-scatterance) in the water column.
